Repair of probes for HP 8405A Vector Voltmeter

by Richard L. Carey, W6RLC, August 12, 2010, note added April 2016 (see last page)

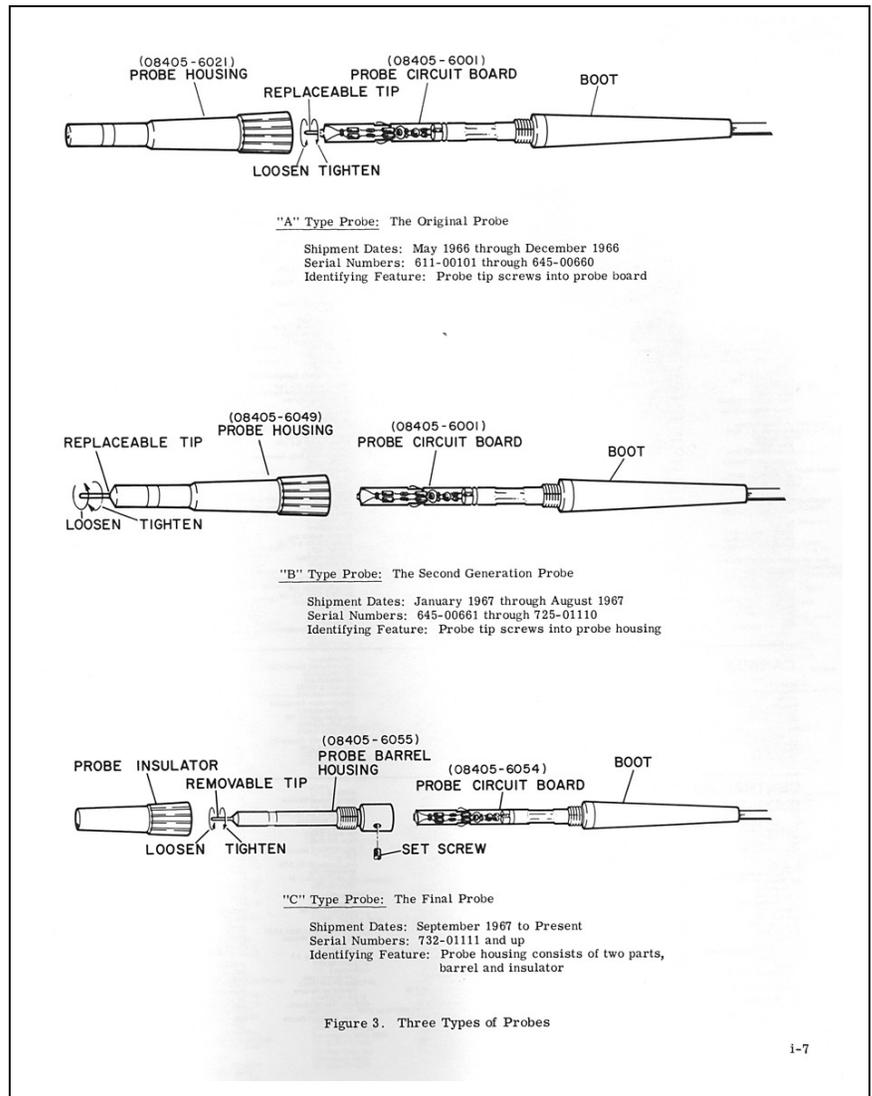
Diode Checks: The board can be pulled out of the body and clamped in a vise to check the four diodes. Using a DVM on the diode range check each of the diodes. I found the left pair, CR1 and CR3 to be OK and the right pair, CR2 and CR4 to be shorted. See the diagram on the next page for probe components.

The diodes were labeled HP1517 and I wasn't able to find any specs on these. I substituted 1N6263 Schottky diodes which are the same size and seem to work fine.

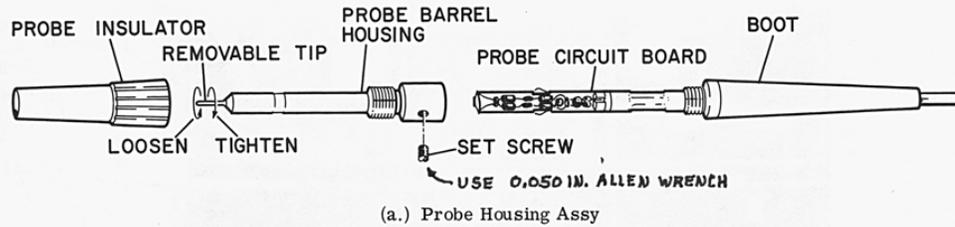
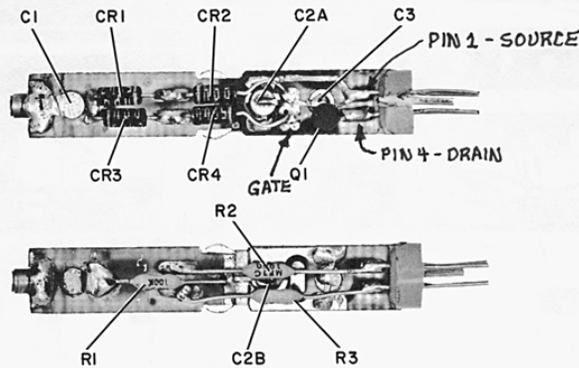
The photo to the right is the probe board with diodes CR2 and CR4 replaced by 1N6263's.

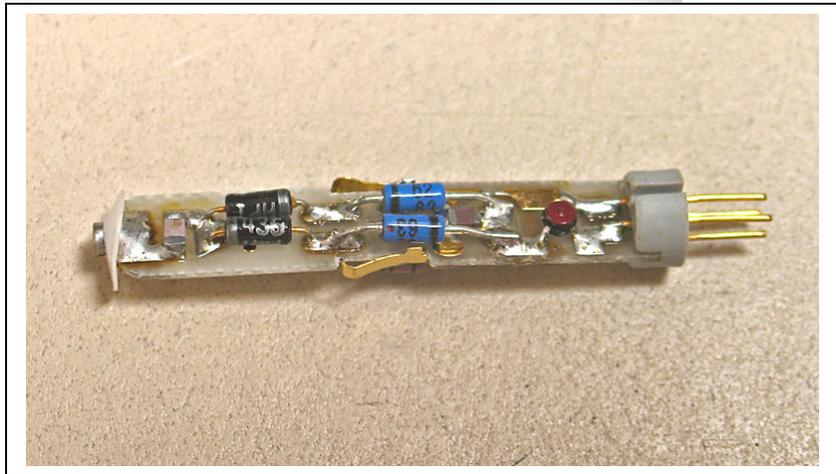
On the right side note the small FET transistor Q1. In this photo the original HP transistor is there.

A small clip lead should be used to clamp to the gold fingers at the middle of the board and ground those to the metal shell to the right of the board. Be careful not to damage these since they ground parts of the circuit when it is inserted back into the metal housing. Note on the drawing above that I have labeled the FET source on pin 1 and the drain on pin 4. The schematic shows that the source should be -2.3 V and the drain at -17 V. Measure these voltages with a DVM with no signal applied.

Q1 Pins	Schematic voltages	Probe A (good)	Probe B (bad)
FET source, pin 1	-2.3 V	-1.4 V	-3.1 V
FET drain, pin 4	-17 V	-17.1 V	-15.9 V

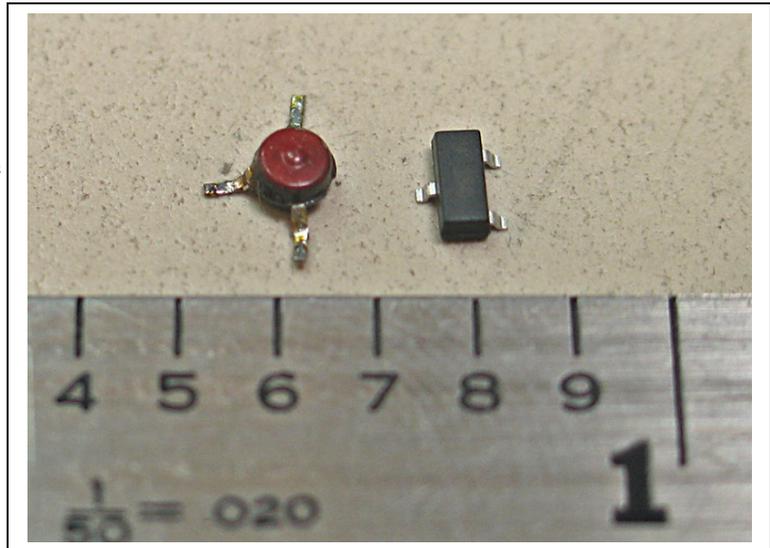
FET Replacement: If the source voltage is off as it was in my case or the 20 KHz signal is bad then the FET needs to be replaced. The photo to the right shows the HP FET which is in a small circular package that is no longer available. The replacement to the right is a modern FET in an SOT23 package used in many surface mount applications. It is small enough to fit on the board.

The replacement P-channel FET I used is a Philips PMBFJ176. There are four FET's in this family with different IDSS values which affect the biasing of the device in the circuit. The PMBFJ176 has an IDSS range of 2 to 35 mA. This is quite a spread so if one doesn't seem to work, try another one. I tried the -174 and -175 models and they didn't seem to work right. This FET is also made by Fairchild and is available from Digi-Key for about 49 cents each.

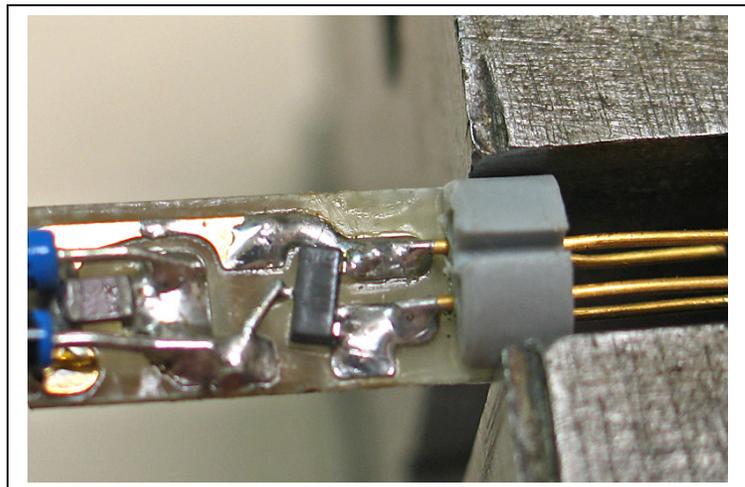
The photo to the right shows the new FET installed. The source and drain match up OK with the board, but the gate does not so I used a fine wire to connect the gate. Use Solder-Wick to clean up the traces and use a very small tip on the soldering iron.

Note: Watch that there is not a sharp edge of solder or conductor extending off the board where the gate lead is. This could short out when the unit is slid into the housing. I also put a small piece of clear Scotch tape over this terminal before sliding into the housing. Here is a table of voltages after the repair. Probe B voltages are much better and close to normal.

Q1 Pins	Schematic voltages	Probe A (good)	Probe B (new FET)
FET source, pin 1	-2.3 V	-1.4 V	-1.7 V
FET drain, pin 4	-17 V	-17.1 V	-16.9 V

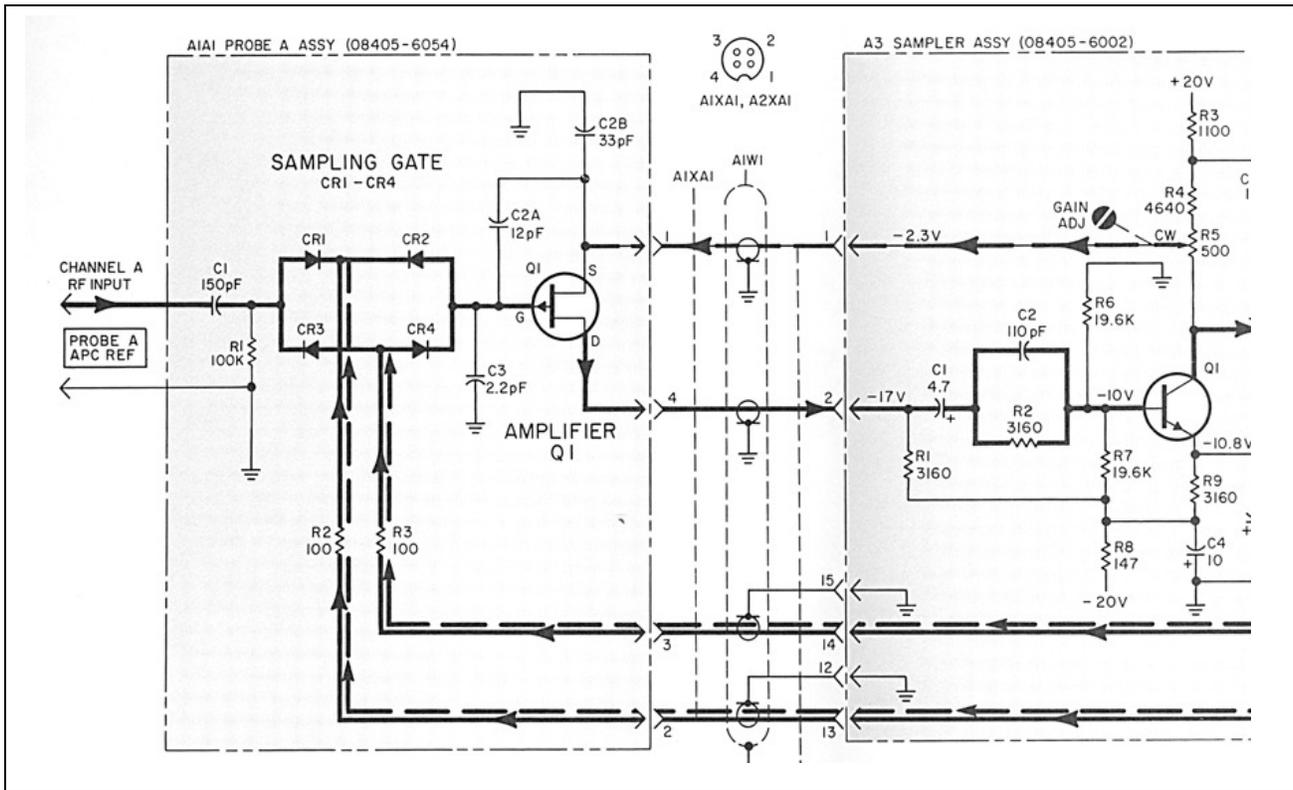
Below is the schematic for the probe and front end of the instrument for reference.
